NOVEMBER, 1955

LOAD TEST OF A DIAGONALLY SHEATHED TIMBER BUILDING

by J. Morley English, A.M. ASCE,
and C. Franklin Knowlton, Jr.

STRUCTURAL DIVISION

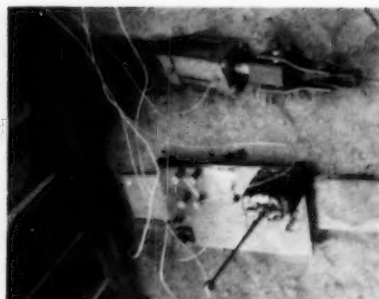
FIG 2

INTERIOR VIEW OF TEST SET UP
(a)

HEEL TIE CONNECTION
(looking up)
(c)

PUMP & JACK SET UP
(d)

DIAGRAM OF TEST LOADING
SET UP
(b)

The building was of wood frame construction, 200' long, 50' wide, with wood curved chord trusses spanning 50' across the building. Fig. 1, Fig. 2. They were installed at 20 foot center-to-center spacing and thus provided ten 20' x 50' bays. The trusses rested on wood posts, which in turn rested on concrete foundations. The roof sheathing was laid at 45° to the joists with the joists spanning between the trusses. The joists were set in hangars. The long walls were designed to be of a minimum type construction, 2 x 4 vertical studs spaced at 16" centers. The studs rested on a wood sill bolted to a continuous concrete foundation. At the top they were connected to a wall plate which was continuous between trusses. By means of metal connections, the wall plate was bolted to the trusses and to the posts which supported the trusses. A splice between the wall plates was provided by extending the truss bearing plate. The building paper, exterior stucco, and interior finish of the building had not been applied at the time of the tests. A horizontal girt member was installed at the sheathing line and flush with the top of the trusses. This girt member extended continuously between the trusses at the heel and was designed to provide strength and stiffness at the boundaries of the roof diaphragm. The design loads used to determine the sizes of the girt members were obtained by assuming that the shear load in any panel was distributed uniformly between the sheathing boards from wall to wall. This, then, introduced an axial load and a bending load into the girt member. An exceedingly large girt member would have been required in the end two bays had not an intercostal strut of blocking been placed at the midspan of the joists. The intercostal was tied by a steel strap extending from wall to wall to ensure that both tension and compression forces could be carried. Nailing was specified to withstand the loads introduced into the girt from the sheathing. The lateral loads were all taken by the end walls. Since a number of openings for windows and doors was required, the end wall shear intensities were high, more than double that for the end roof panels. The window and door opening were reinforced to provide for the high stresses.

1. Loading (See Fig. 2)

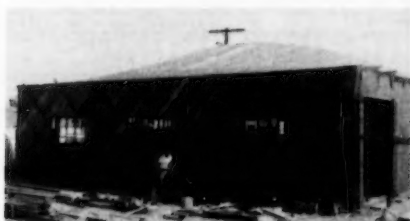
FIG. 3

NORTH END OF BUILDING

STRUCTURAL ELEMENTS-NORTH END

In the back wall, Fig. 3, the piers (b) were all of uniform size. This made the problem relatively simple since all could be assumed to carry the same shear intensity. It was also assumed that the total shear was constant across the building. Consequently, the shears in sub-panels d and f were determined by taking a vertical section through a window, and in sub-panels b by a horizontal section through the windows. Now by elimination the shears in sub-panels c and d were established. The change in shear intensity from one

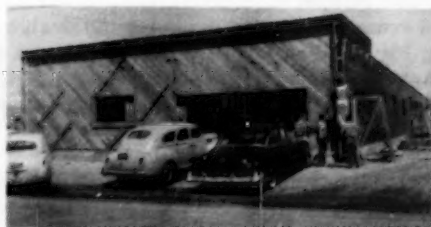
FIG 4

SOUTH END OF BUILDING

STRUCTURAL ELEMENTS - SOUTH END

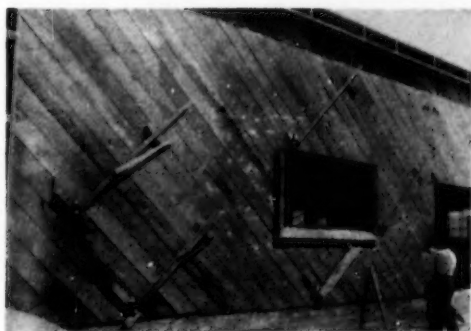
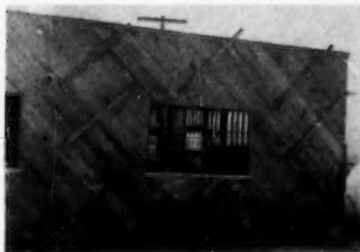
FIG 5

SOUTH WALL GAUGE SET-UP
(a)

TYPICAL GAUGE DETAIL
(b)

NORTH WALL GAUGES
(c)

1) On the end shear walls to record deformations perpendicular and parallel to the sheathing over gauge lengths ranging from 40" to 60", Fig. 5. This was attempted by nailing an indicator board on the wall in such a way that movement at the far end was recorded on the gauge as the accumulated deflection over the length of the board. Since only one end of the board was nailed to a sheathing board it was not possible for the indicator board to be stressed. However, rotation in the sheathing could occur and thus render it impossible to determine the component of deflection due purely to translation by the reading of dial A.
